The Fate of Coracoid Graft after Latarjet Procedure: Arthroscopic and Open Findings of Graft Union and Glenoid Remodelling

ABSTRACT

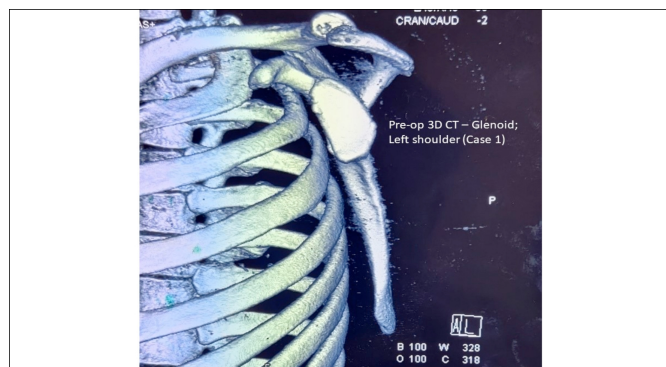
Figure 1: Case 1 - CT (3D) image; Preoperative; left shoulder.

Computed tomography (CT) showed a bony Bankart lesion with 25% bone loss (Figure 1). He underwent an open Latarjet procedure, accompanied by capsular plication using two SutureTak anchors (Arthrex, Inc) (Figure 2). This combination is the authors' preferred technique for shoulder stabilisation in patients with more than 20% bone loss. The patient's immediate postoperative period was uneventful, and he underwent a full range of rehabilitation with good compliance and was asymptomatic for the next eight months.

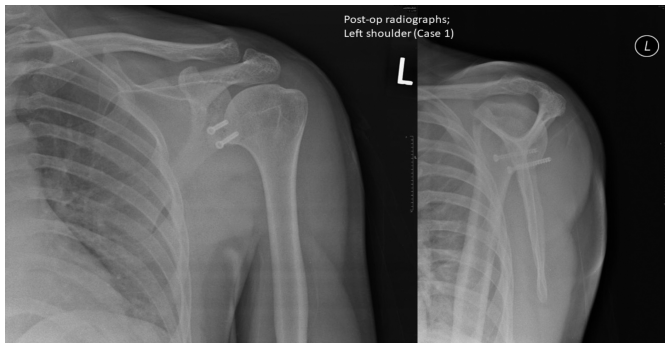
Figure 2: Case 1 - Postoperative radiographs; left shoulder.

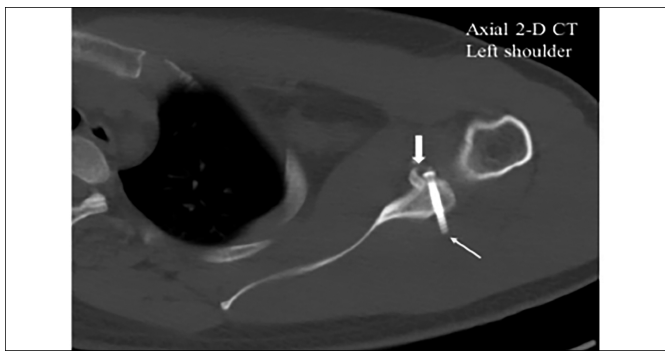
Figure 3: Case 1 - CT (2-D) image; note the united coracoid graft (bold arrow) with posterior prominence of inferior screw (thin arrow); left shoulder.

albeit with significant prominence of his inferior screw posteriorly over the glenoid. There was minimal graft resorption, and the screw heads were not prominent over the graft (Figure 3). The MR imaging also showed an intact posterior labrum, ruling out the possibility of multidirectional instability.

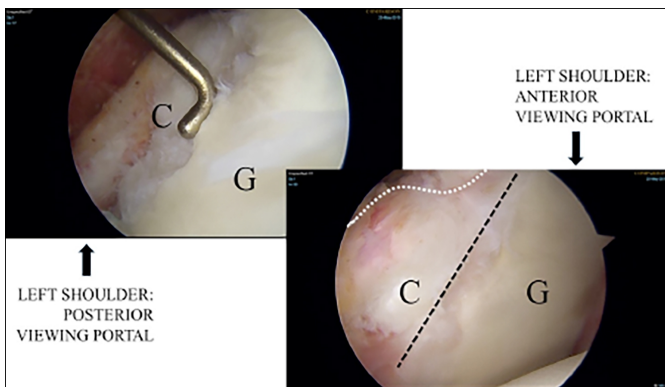
Figure 4: Case 1 - Left shoulder arthroscopic image showing the united coracoid graft (C), with glenoid (G) retaining its original shape, as seen from 2 portals - anterior and posterior.

At one-year, he underwent diagnostic arthroscopy of the left shoulder followed by a mini-open removal of both coracoid screws. Arthroscopy revealed a detached anterior capsule plication with prominent suture remnants within the native glenoid margin. The coracoid graft was noted to be united well, and the glenoid has attained its native shape (Figure 4). There was presence of fibrocartilage-like tissue in between the native cartilage and the remodelled graft. The shoulder did not dislocate at extreme abduction - external rotation position.

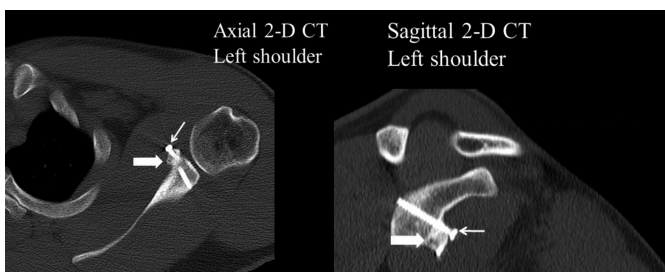
Figure 5: Case 2 - CT (2-D) images; showing united coracoid graft (bold arrow) and prominent proximal screw head (thin arrow); left shoulder.

Postoperative CT scan done at four and six months revealed that the coracoid graft had united with some resorption of the upper part of the coracoid graft, rendering the proximal screw-head a little prominent (Figure 5). The posterior ends of both screws were not protruding. The prominent proximal screw-head was thought to be the cause of the clicking due to attrition

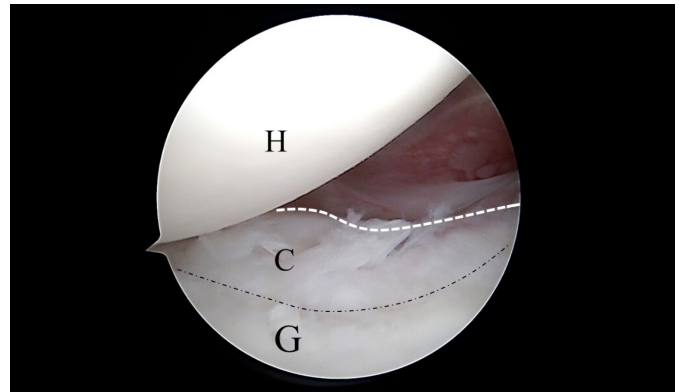
Figure 6: Case 2 - Left shoulder arthroscopic image showing the united coracoid graft (C) to the glenoid (G), and the humeral head (H). The dotted white line indicates curvature representing upper graft resorption, and the dotted black line represents coracoid-the glenoid junction.

Diagnostic arthroscopy revealed that the coracoid graft has united, with near-normal glenoid remodelling at six months' postoperative period (Figure 6). Removal of screws was uneventful, and upon direct palpation, the coracoid graft was confirmed to be solidly united to the glenoid. Postoperatively, he had started back on his gym routines without any discomfort. However, clicking was still present albeit being painless and not causing limitations of his gym and daily activities.
